Pedestrian Safety Countermeasures Along Delaware's SR 1 Beach Corridor

Roadway Management Conference 2021

Peter Haag, P.E., PTOE
Delaware Department of Transportation
Chief of Traffic Engineering

Kyle Clevenger, P.E., PTOE
Whitman, Requardt & Associates, LLP
Senior Project Engineer

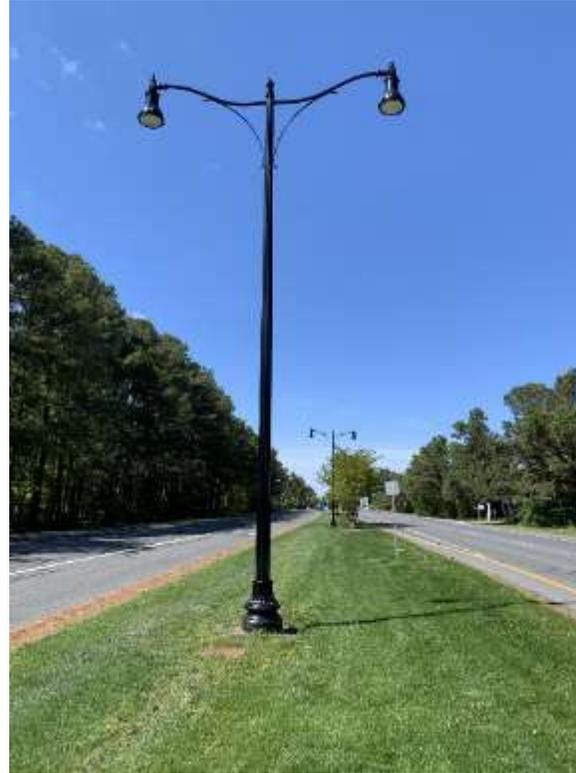
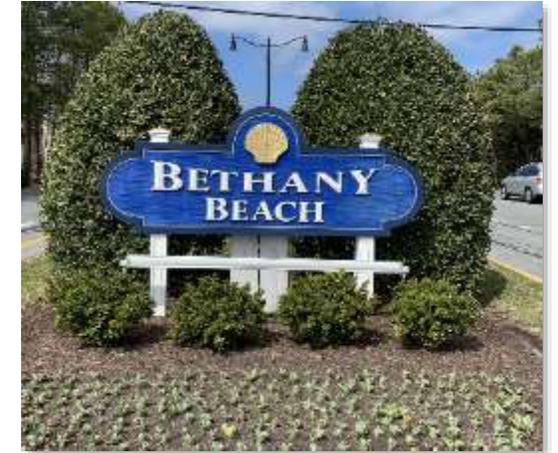
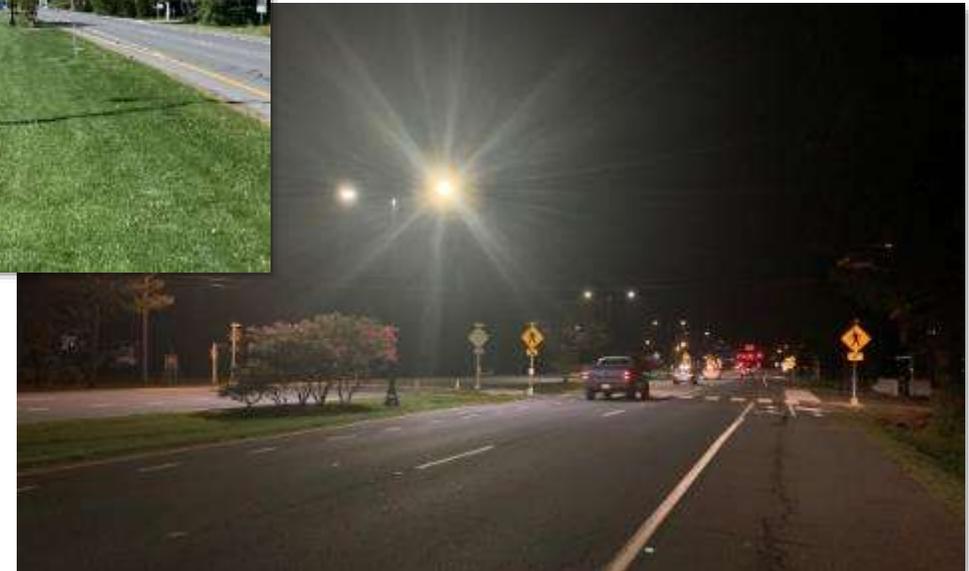
Roadway Lighting:

- Twin arm decorative light standards in the median of SR 1
- Nearly 3 miles of continuous roadway lighting – 87 light poles total
- \$1.56 million total
- 3 separate lighting systems:
 - Town of Bethany Beach
 - Town of South Bethany
 - DeDOT (Middlesex Beach/Sea Colony unincorporated area)

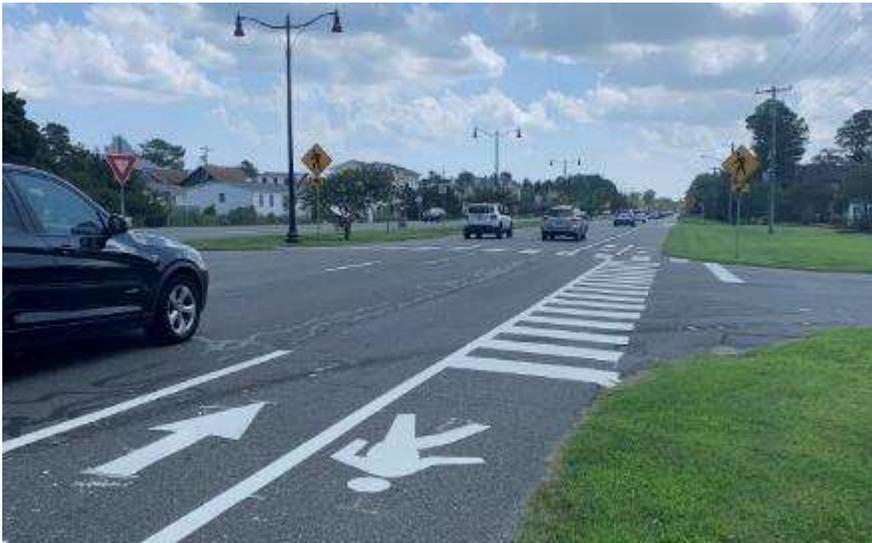
Town of Bethany Beach – Striping Improvements

- No sidewalks along SR 1 → shoulder serves as defacto pedestrian access route and bike lane
- Installed pedestrian and bicycle markings along the SR 1 shoulders to delineate proper areas/directions of travel, educate road users and enhance the conspicuity of pedestrian crossings and conflict areas

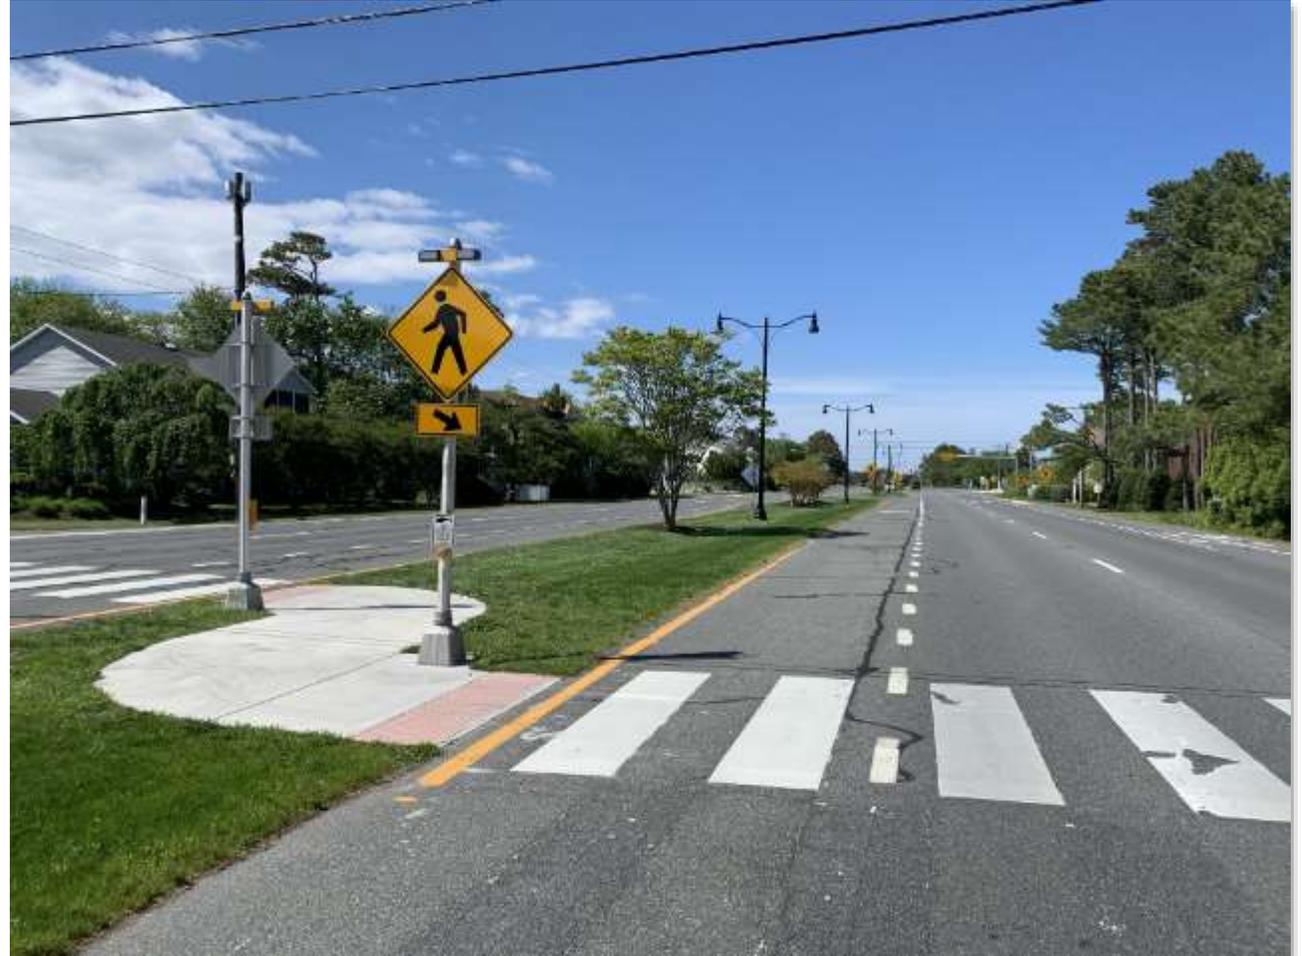
RRFB Improvements – Bethany Beach

- 3 new RRFBs installed
 - Wellington Parkway
 - Central Boulevard
 - Oceanview Parkway
- Bethany Beach provided construction funding for one location
- Selected locations based on land use and pedestrian desire lines

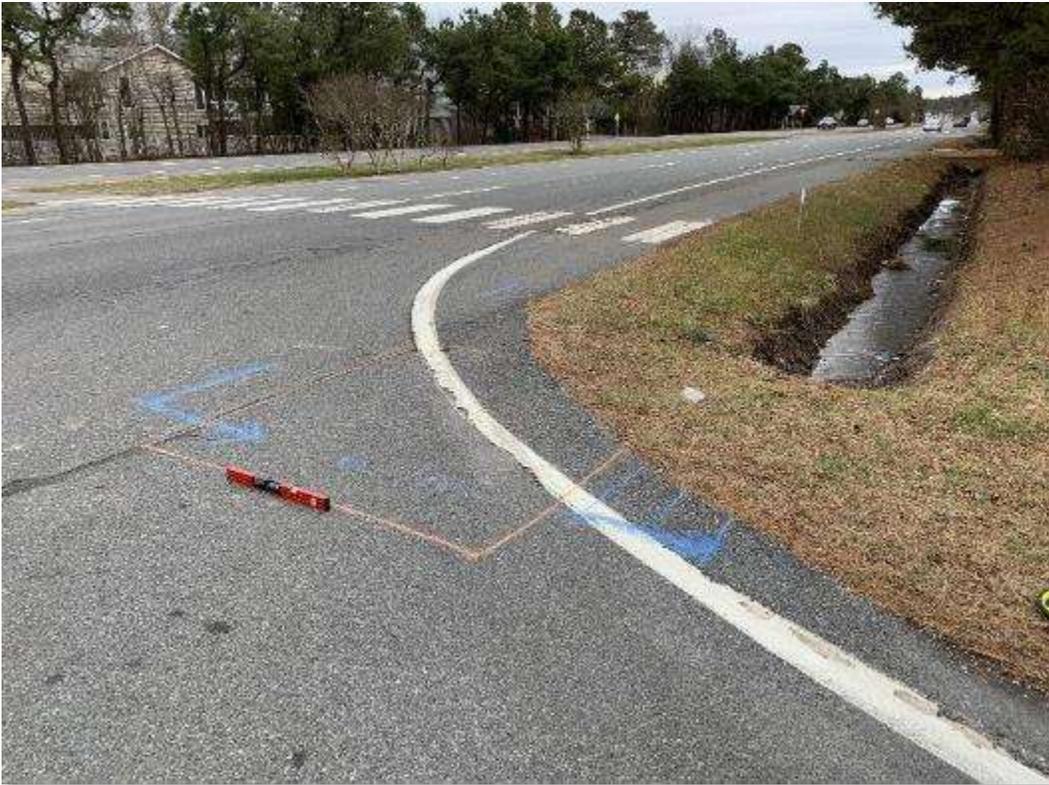
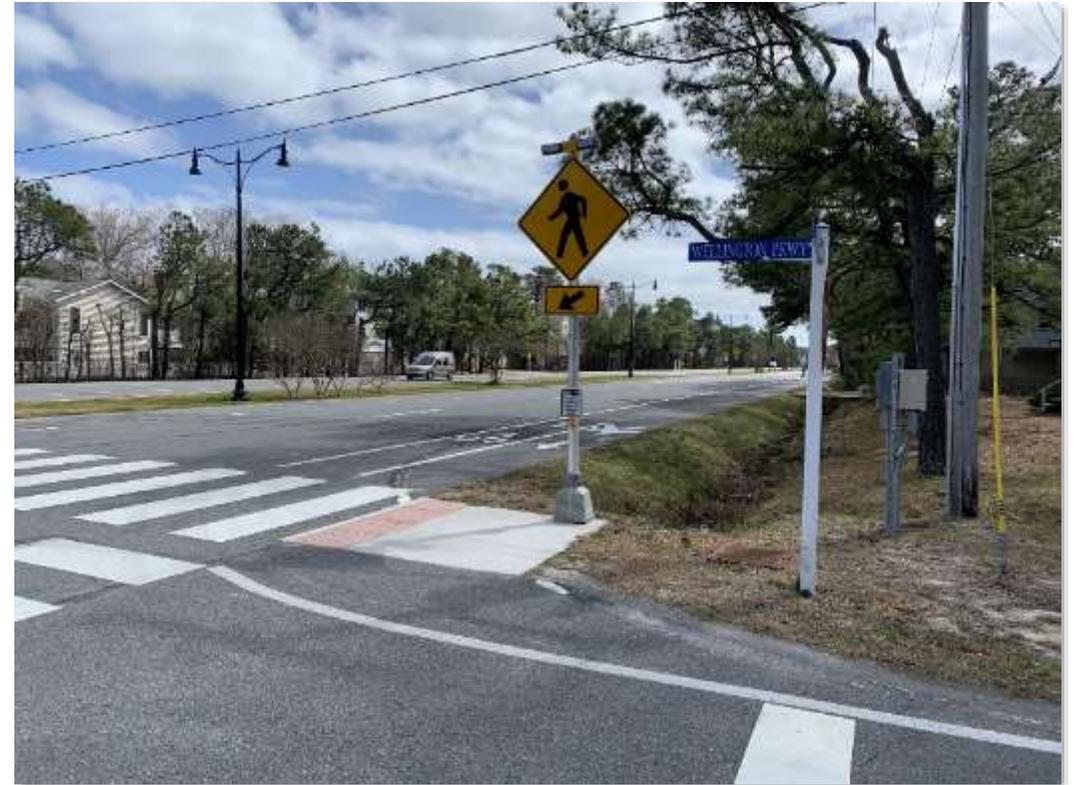
- Roadside constraints required “stealing” existing pavement and shifting crosswalk locations to provide ADA compliant landing areas

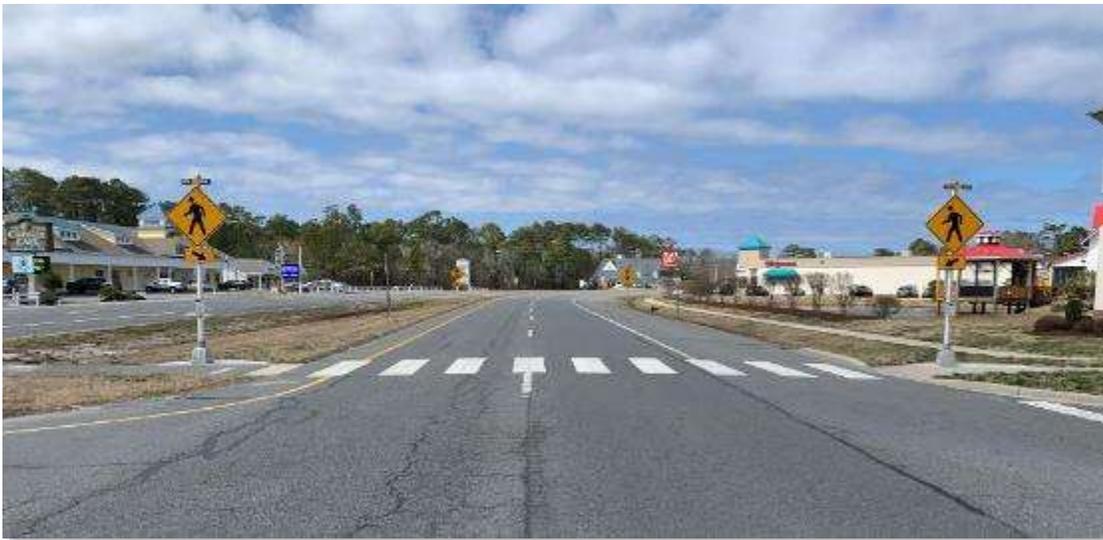
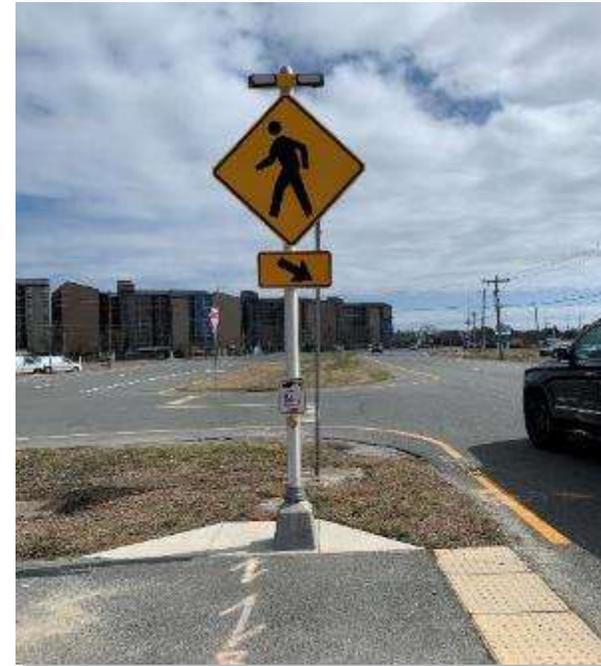
RRFB Improvements – Middlesex Beach / Sea Colony

- 2 new RRFBs installed
 - Marketplace / Hickman Plaza
 - Bridge Road

- Locations based on crash data and coordination with Middlesex Beach Association
- Additional RRFBs being considered in Middlesex Beach area for FY22-23

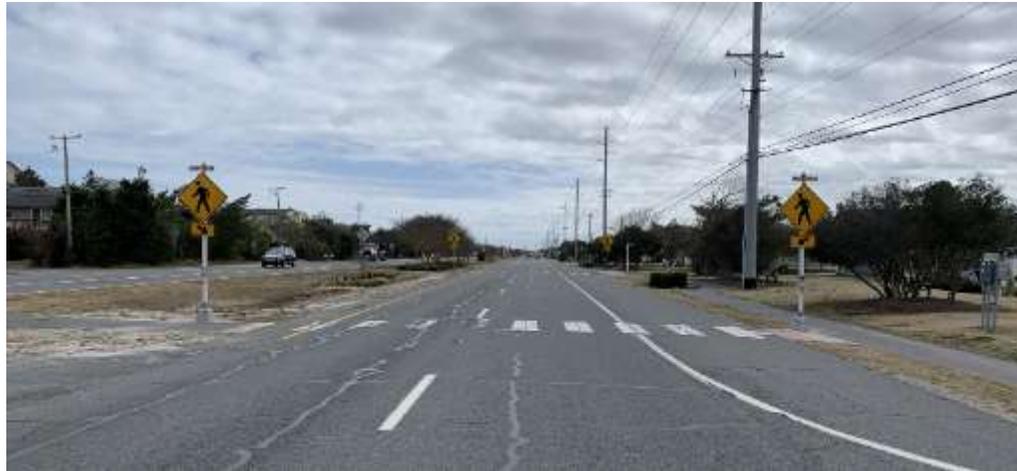
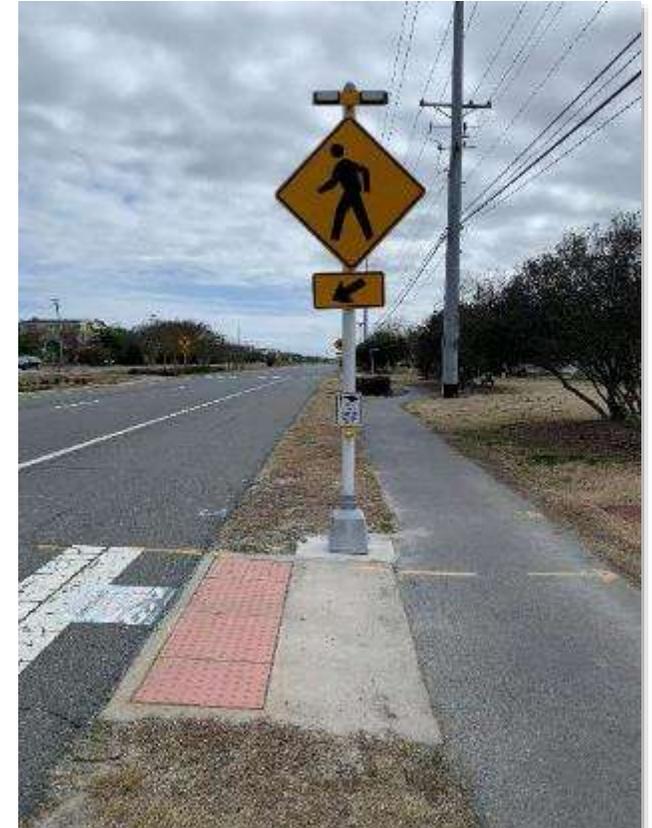
RRFB Improvements – South Bethany

- 4 new RRFBs installed
 - Anchorage Drive
 - Petherton Drive
 - Henlopen Drive
 - Bayshore Drive
- Locations based on land use and pedestrian desire lines
- Locations coordinated with DeIDOT Planning and new bicycle parking racks

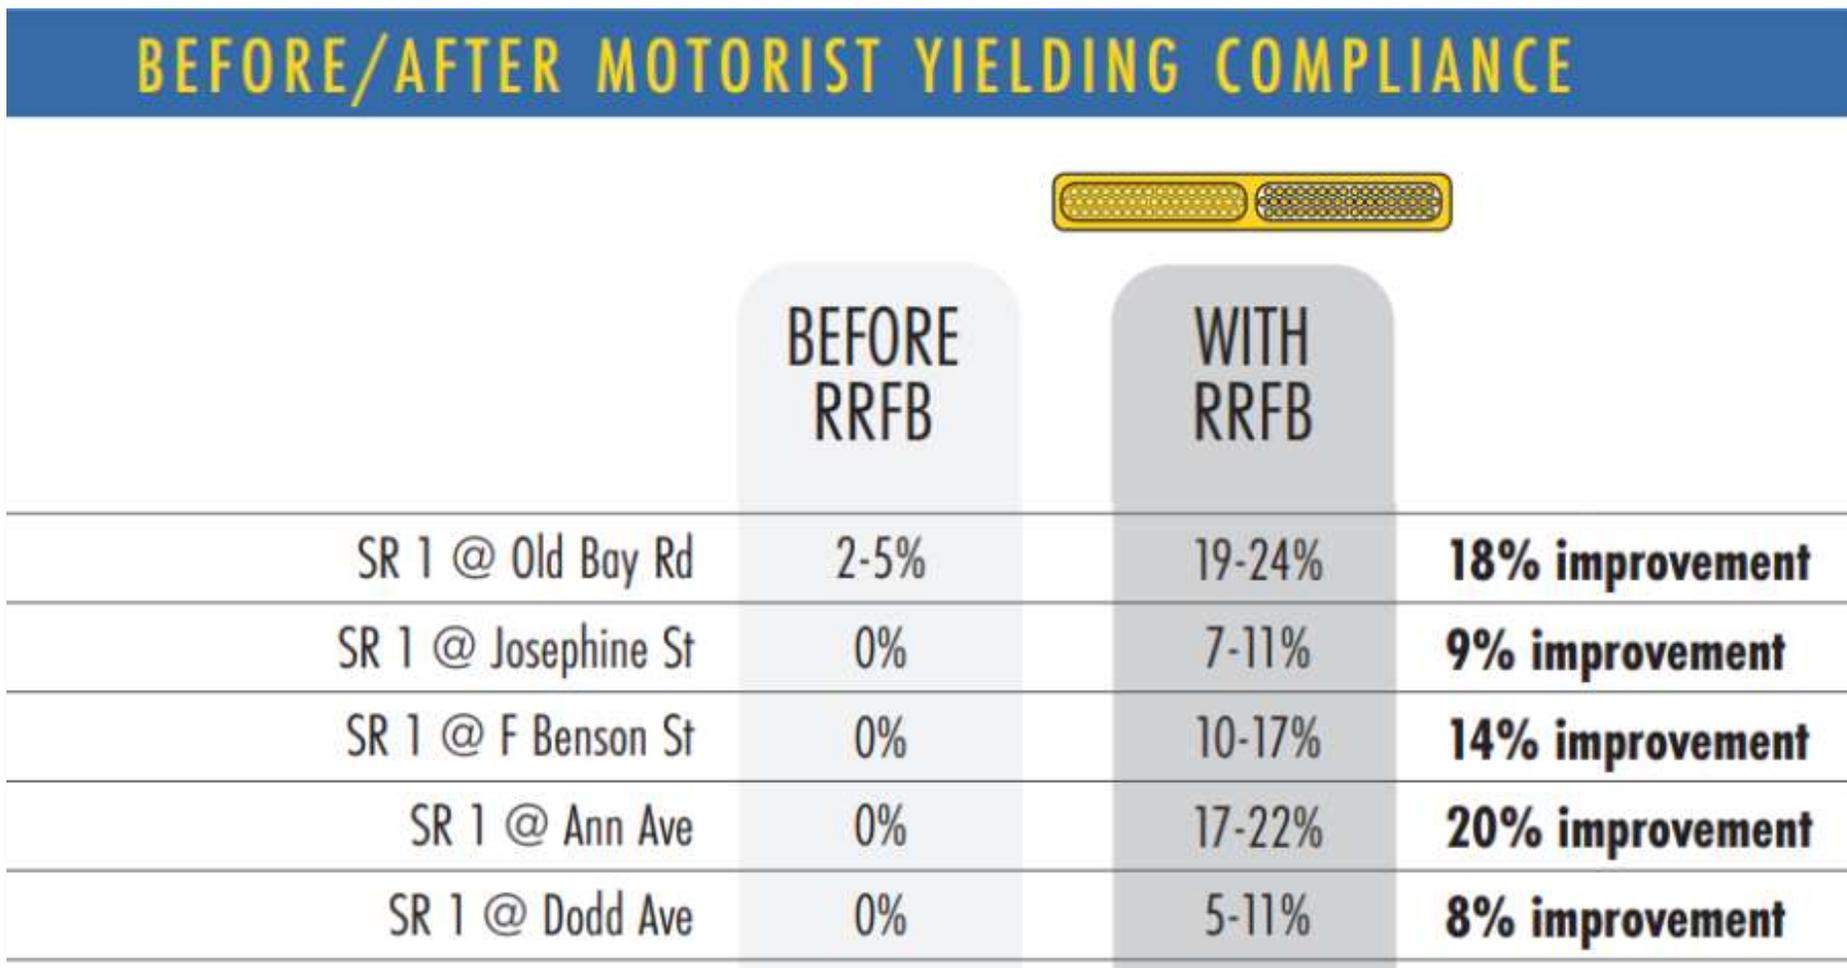
SR 1, Rehoboth Canal to Dewey Beach Northern Limits Results:

Measure of Effectiveness	Before RRFB	After RRFB
Avg # Not Yielding	14	4
Avg Ped Delay (sec)	30	14
Avg # Not Yielding if first vehicle doesn't yield	15	5
Avg Delay if first vehicle doesn't yield (sec)	31	17
Avg Delay, Yield Crossing (sec)	20	13
Avg Delay, Gap Crossing (sec)	31	16
% Yield Crossings	8%	46%
% Gap Crossings	92%	54%
% First Vehicle Yields	2%	18%

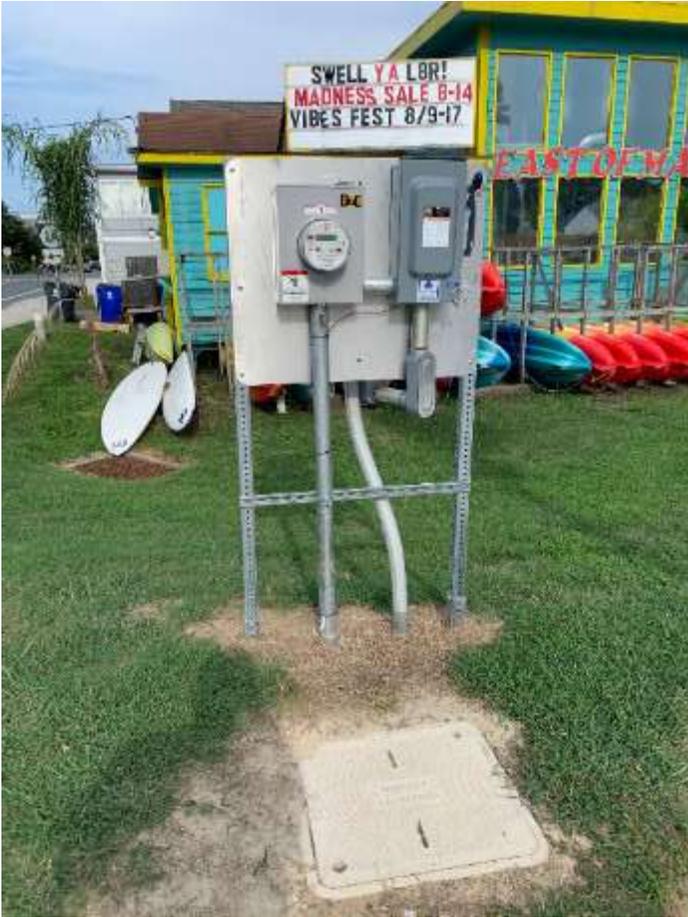
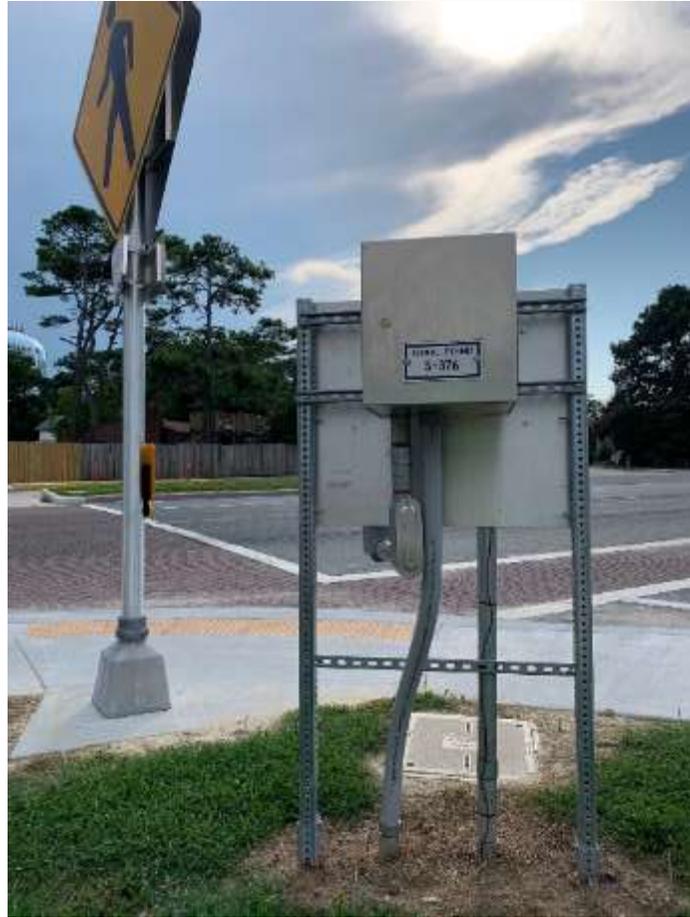
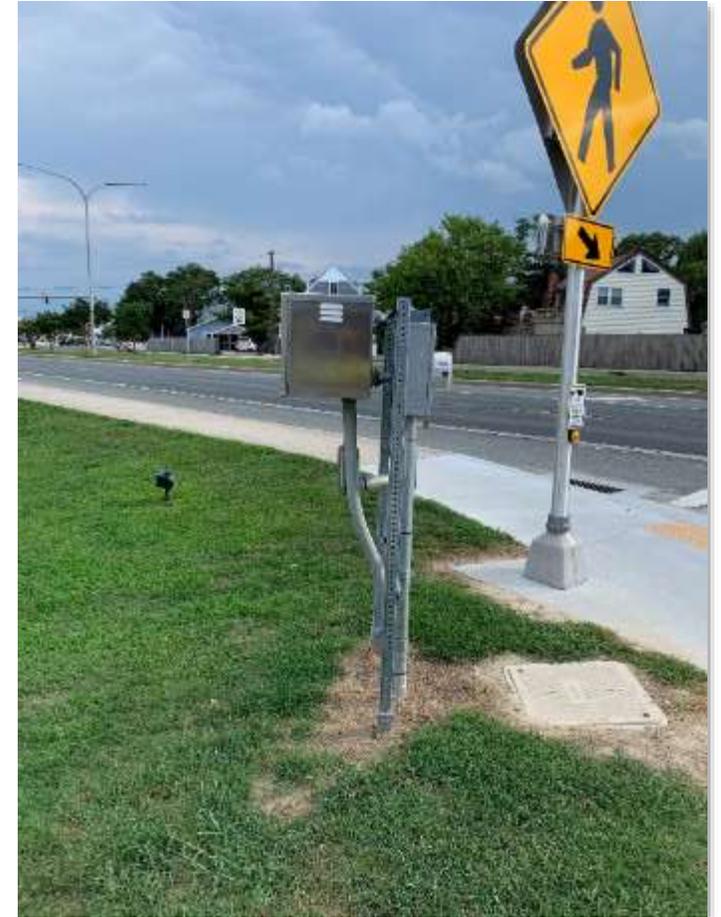
Typical Hardwired Power Feed / Cabinet Setup

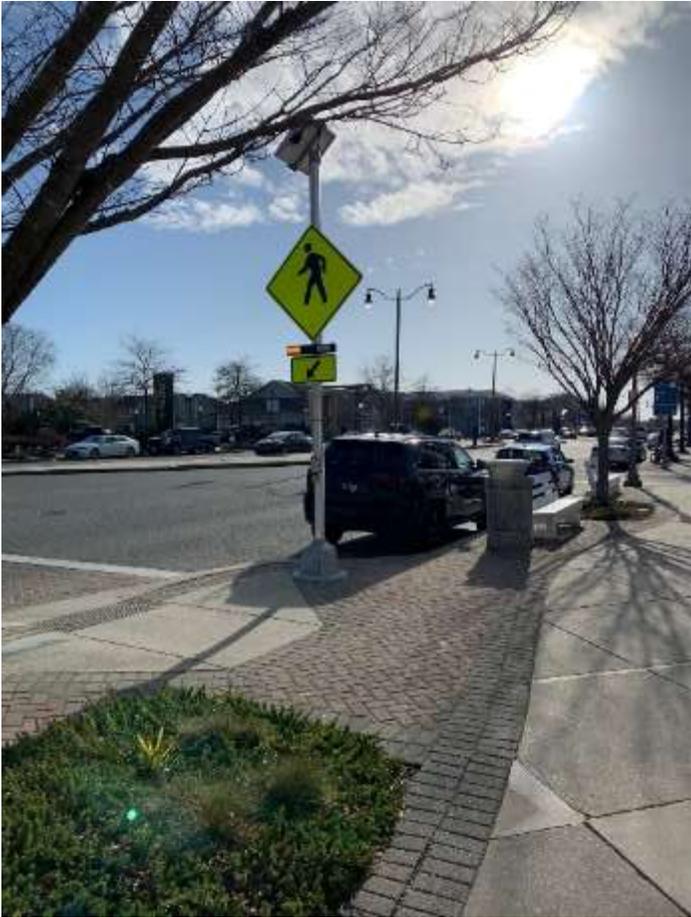
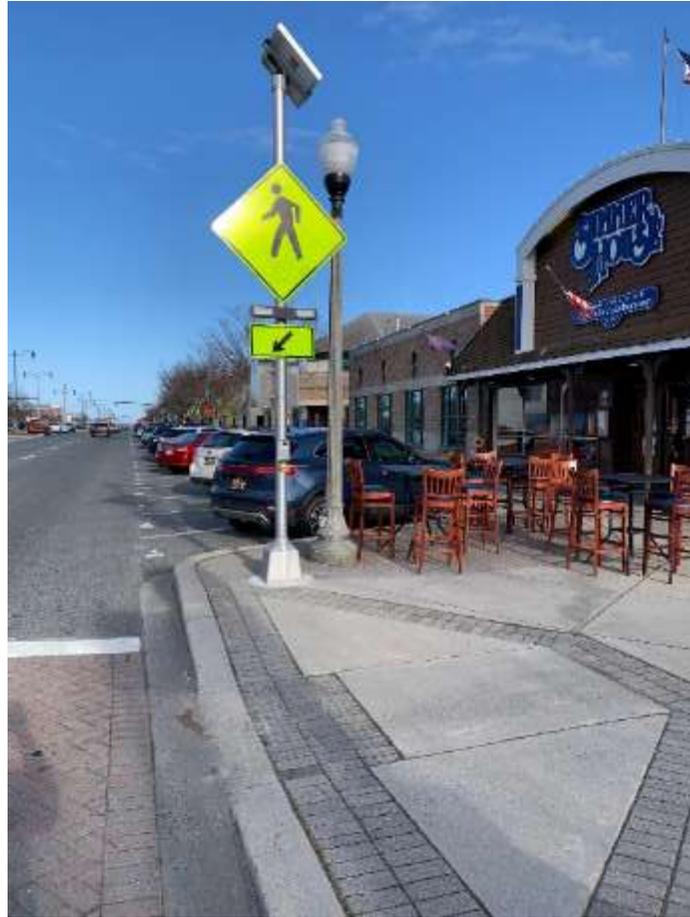
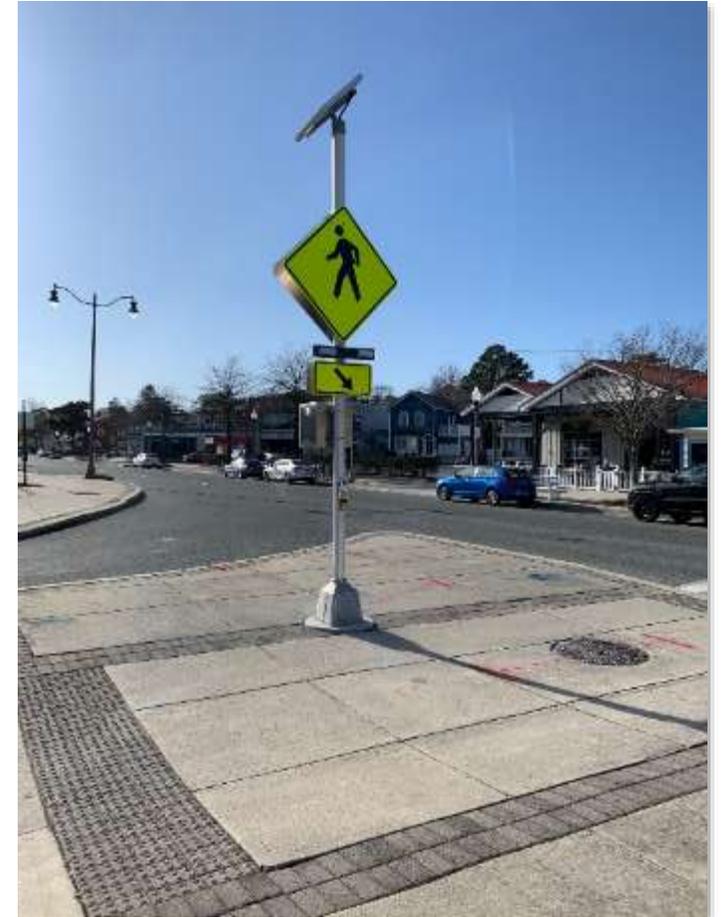
Example municipally-funded solar RRFB setups

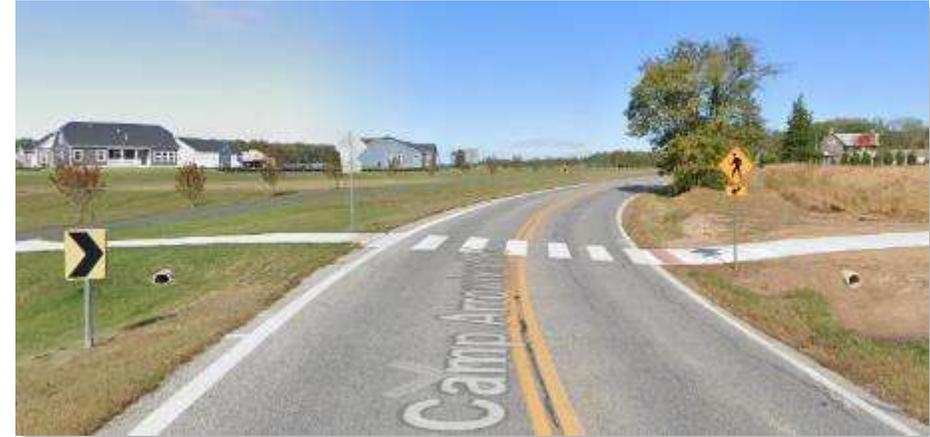
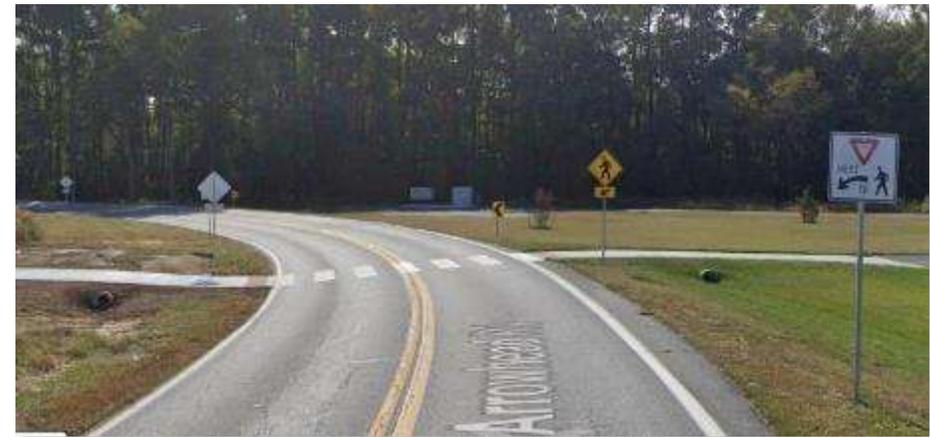
Outside-the-Box RRFB Accommodations – Advance Flashers for Poor Sight Distance

- Developer-funded trail crossing on Camp Arrowhead Road near Long Neck, DE
- Horizontal geometry limits sight distance for pedestrian crossing
- The pushbuttons at the crossing location will activate advance “AHEAD” flashers to actively warn approaching motorists of pedestrian activity

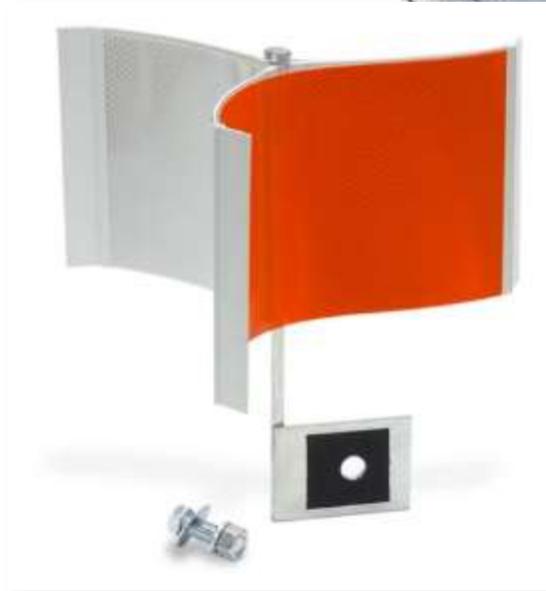
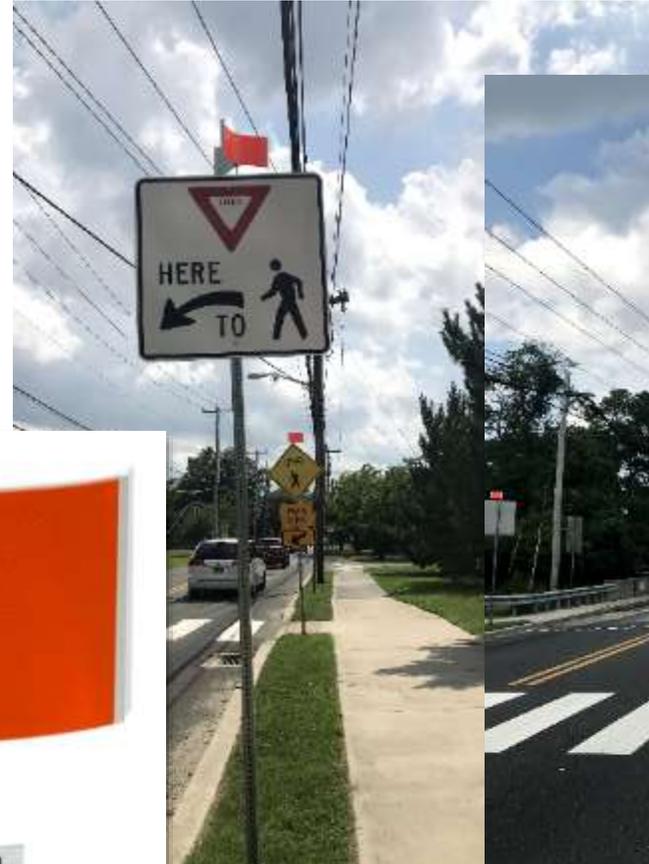
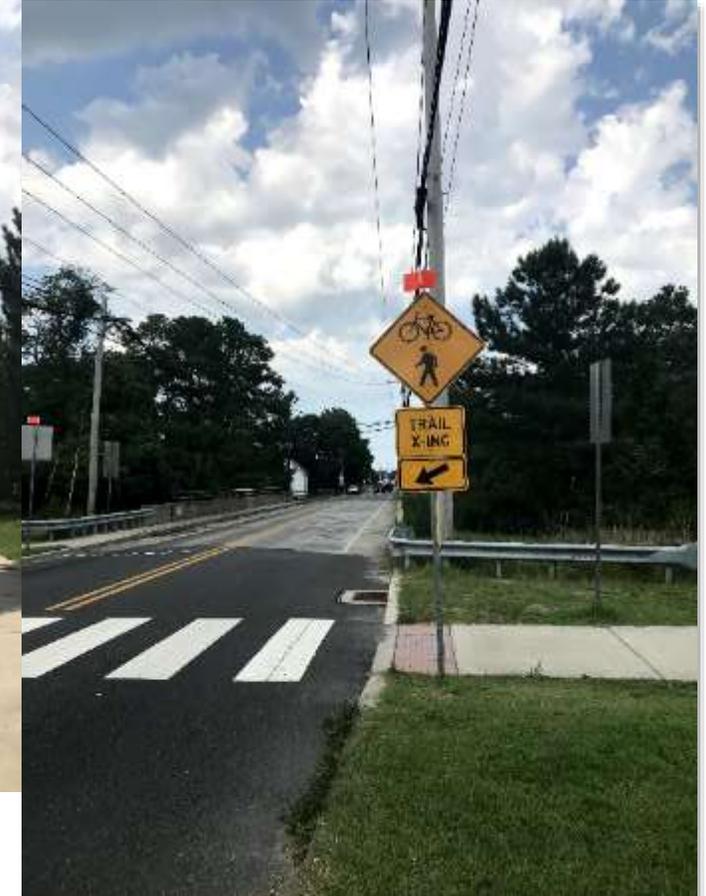
- “Spin Alert” hazard warning device
- Not recognized by MUTCD as a traffic control device – limited experimental use in DE
- Pilot location study – Beaver Dam Rd at St. Georges Chapel near Lewes, DE
 - Immediately following installation, driver compliance improved from 0-9% to 33-64%
 - Six months later, compliance rates decreased to 16-26%, but still an improvement over pre-existing conditions

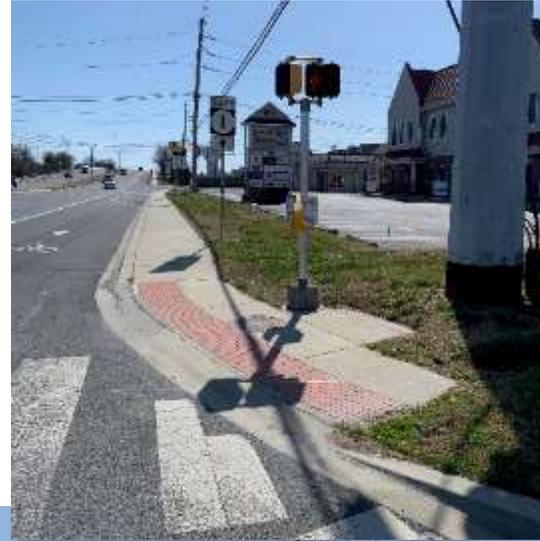
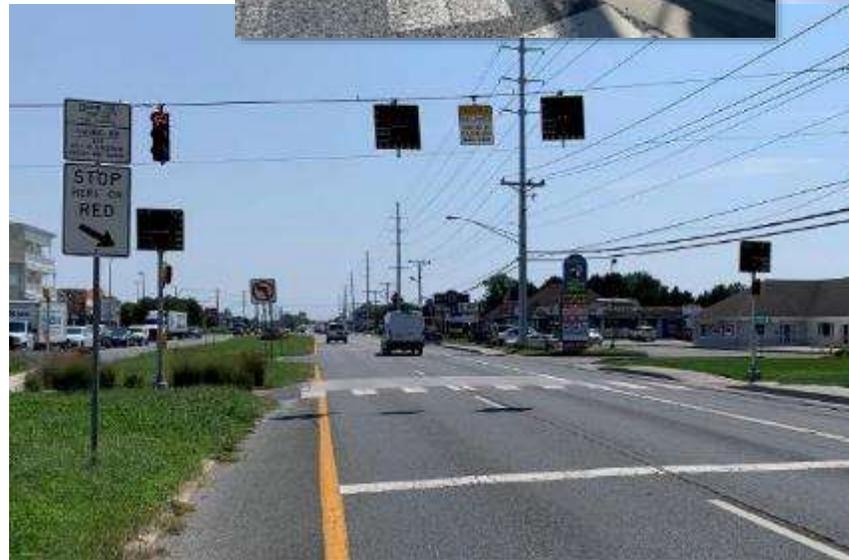
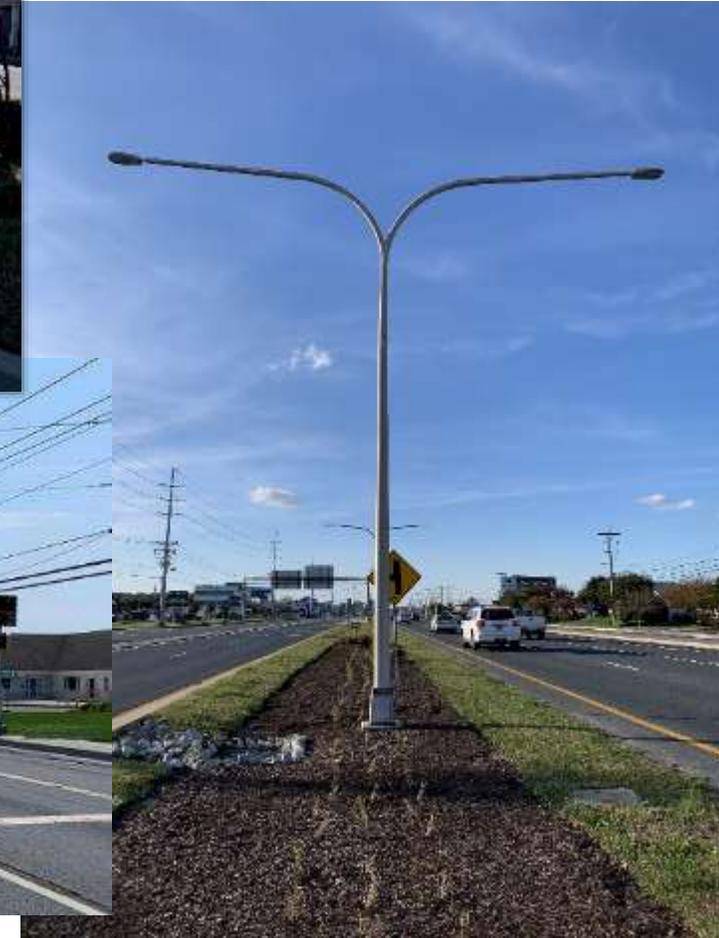
- SR 1 – Rehoboth Canal to North of US 9 (Five Points) Pedestrian Improvements
 - Project elements included:
 - 6 miles of continuous sidewalk along both sides of SR 1
 - 6 new signalized crossings of SR 1
 - 2 new HAWK beacons
 - Lighting Improvements
 - Bus/Bike/Right-Turn Lane Signing and Striping
 - Transit improvements

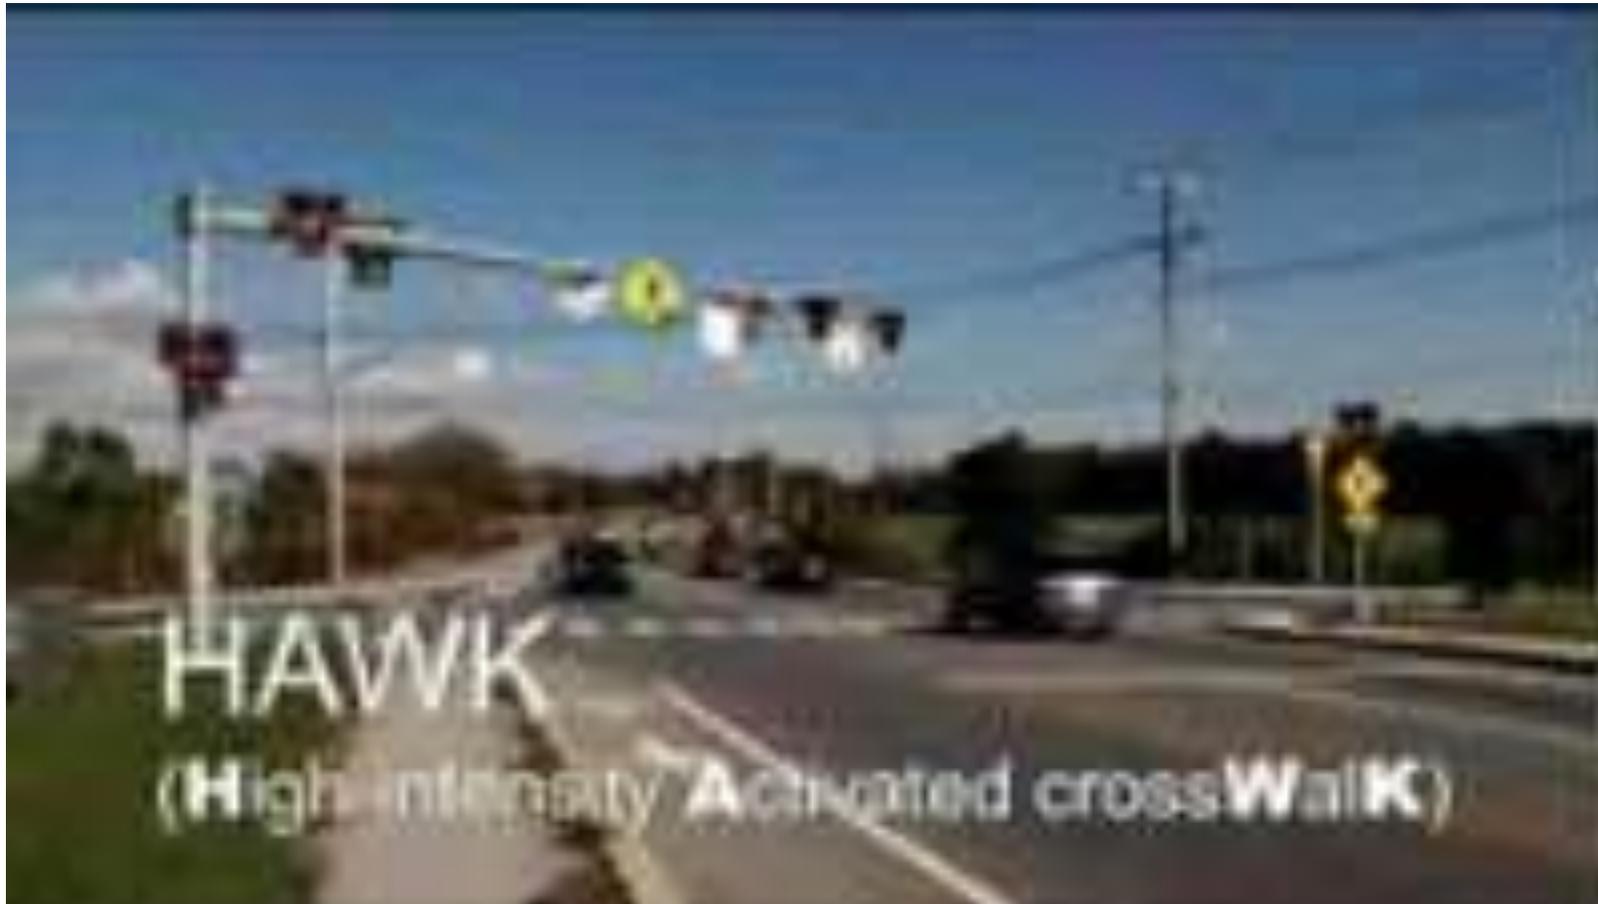
Pedestrian Hybrid Beacons (HAWK) – How do they Operate?

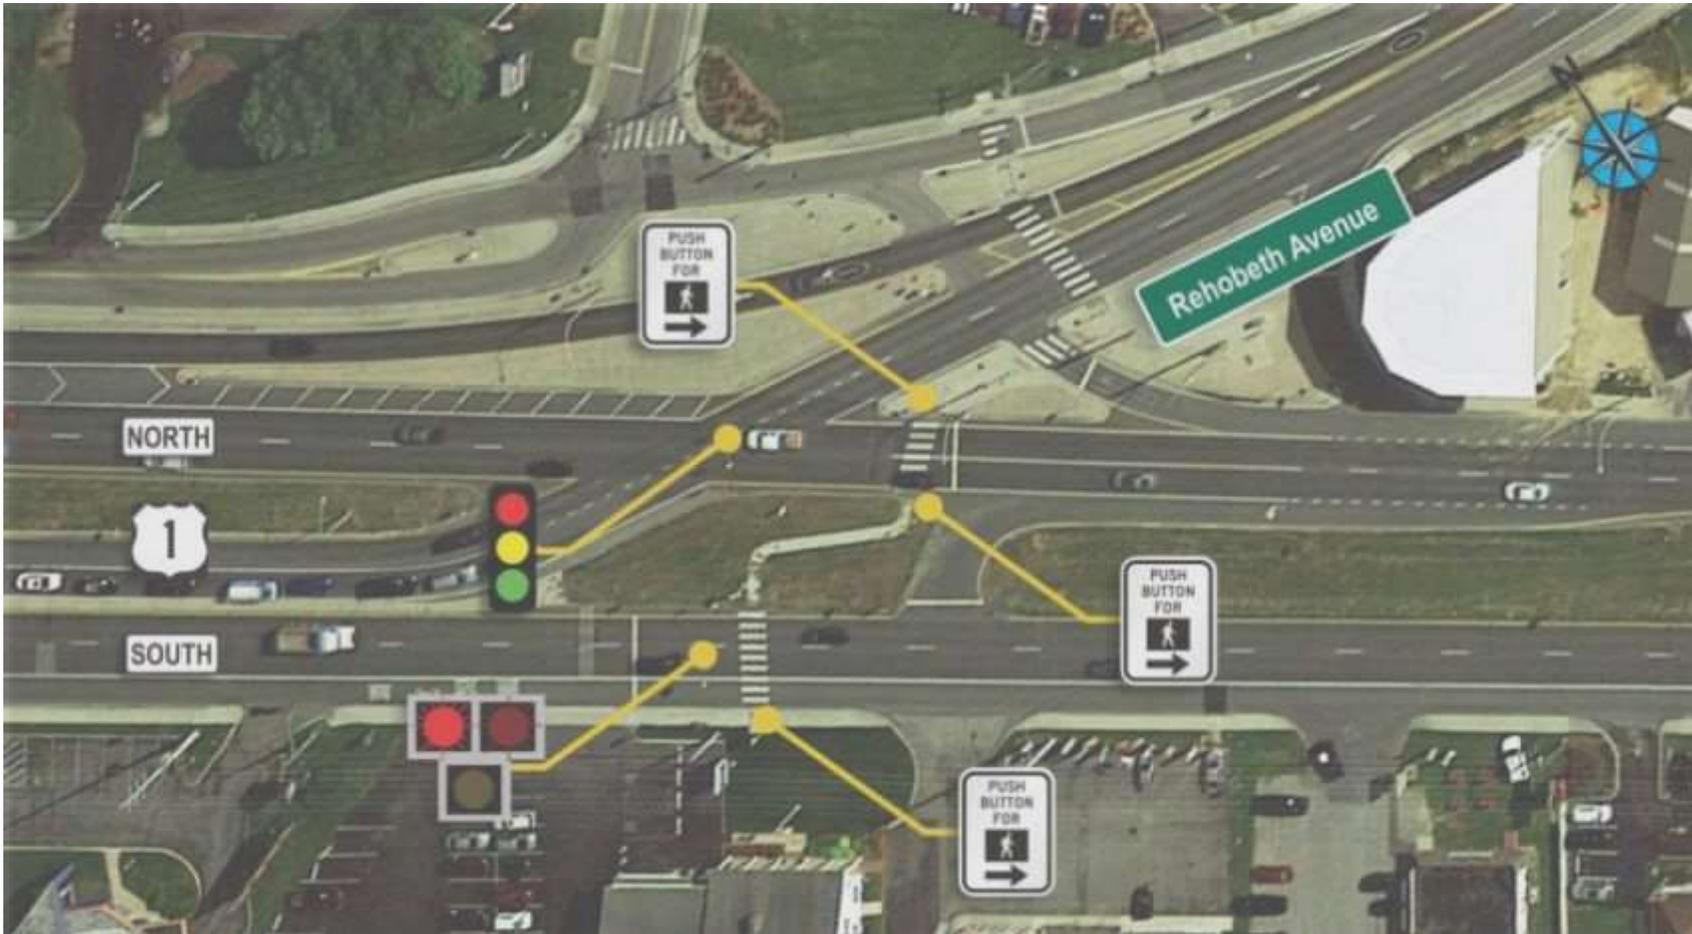
Pedestrian Hybrid Beacons (HAWK) -SR 1 @ Rehoboth Avenue (SR 1 SB only)

- SR 1 at Rehoboth Avenue:
 - Motorist Compliance down from 87% in 2016 to 59% in 2019
 - Pedestrians and bicyclists frequently activate HAWK, but cross before the HAWK signal activates. Subsequently, many non-complying vehicles observed when no pedestrians or bicyclists are present
 - Total crashes have increased by 27% since installation
 - Zero bike/ped crashes prior to installation; 1 pedestrian and 3 bicycle crashes since installation, although none attributable to the HAWK signal
 - Westbound pedestrians less likely to wait for the HAWK signal to activate and cross properly after completing 3 previous stages of the crossing (4-stage crossing of SR 1 / SR 1A)

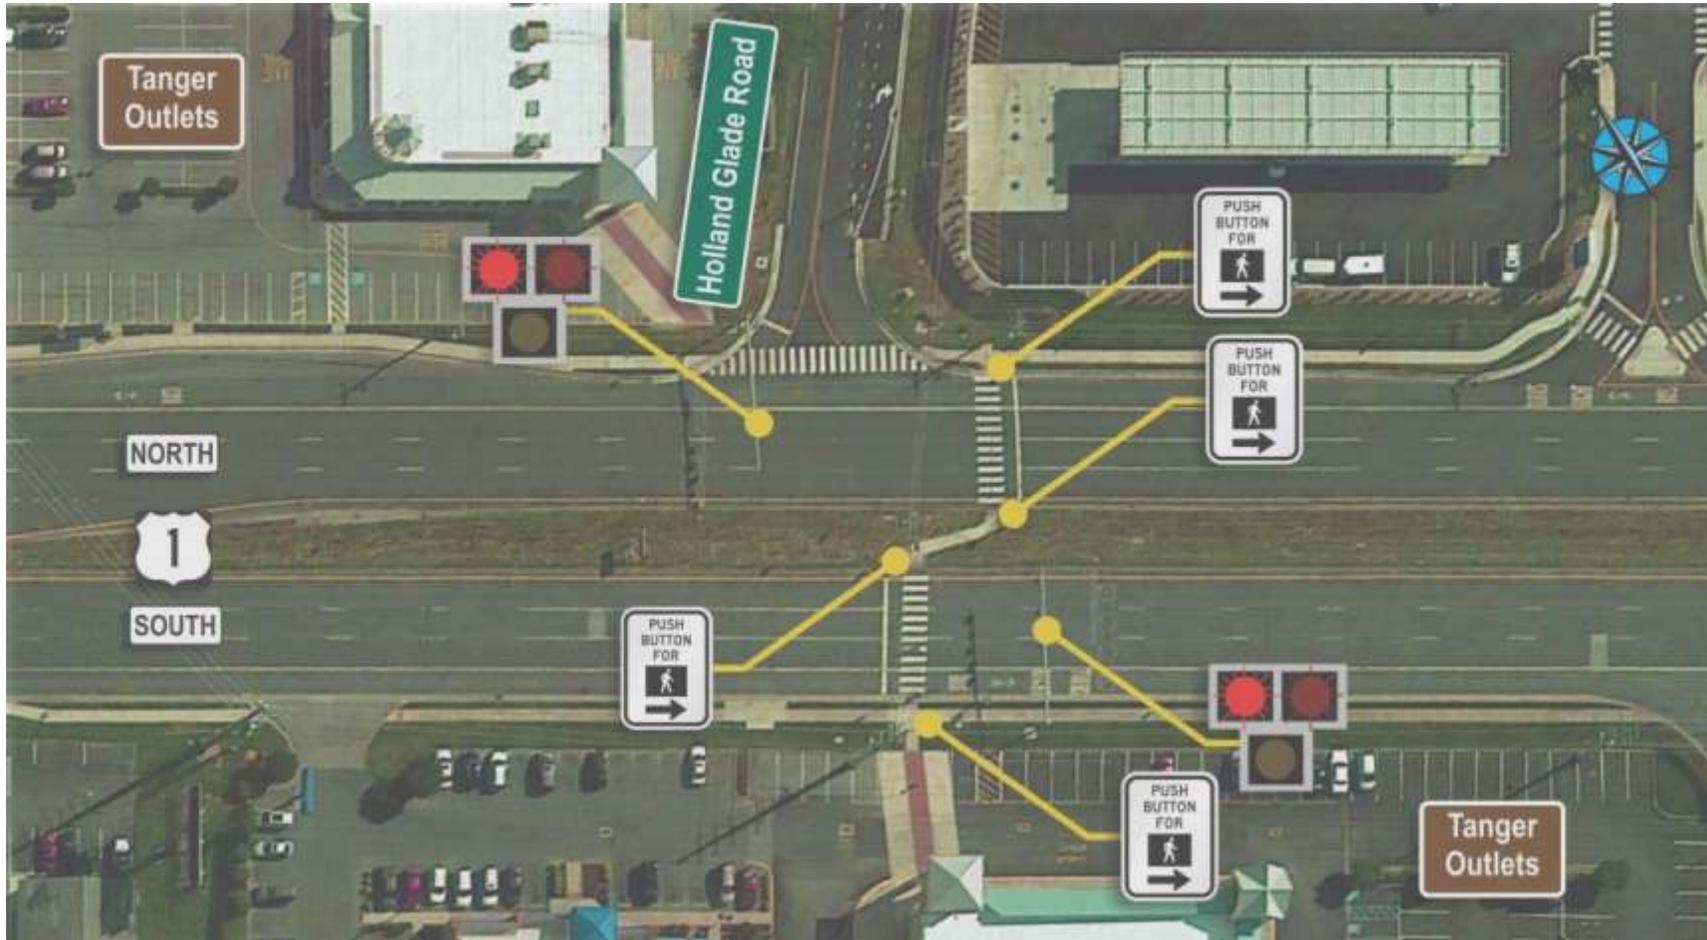
Pedestrian Hybrid Beacon (HAWK) - SR 1 @ Holland Glade Road

- SR 1 at Holland Glade Road:
 - Motorist Compliance down from 97% in 2016 to 72% in 2019
 - Pedestrians and bicyclists frequently activate HAWK, but cross before the HAWK signal activates. Subsequently, many non-complying vehicles observed when no pedestrians or bicyclists are present
 - Motorists observed speeding up during flashing yellow to “beat the light”
 - Total crashes have increased from 29 to 62 since installation of the HAWK
 - Bicycle crashes increased from 1 to 8 since installation of the HAWK signal, including one involving a bicyclist being hit by a motorist that disregarded the signal and 3 other crashes attributed to the HAWK
